July 14, 2022

Structural Observation  
Hayswood Hospital  
2-98 W 4<sup>th</sup> St.  
Maysville, KY

Per your request, Yeiser Structural has performed a visual observation of the above referenced project to determine the existing structural deficiencies and any anticipated repairs. Per information obtained, the proposed use of the structure is to become apartments.

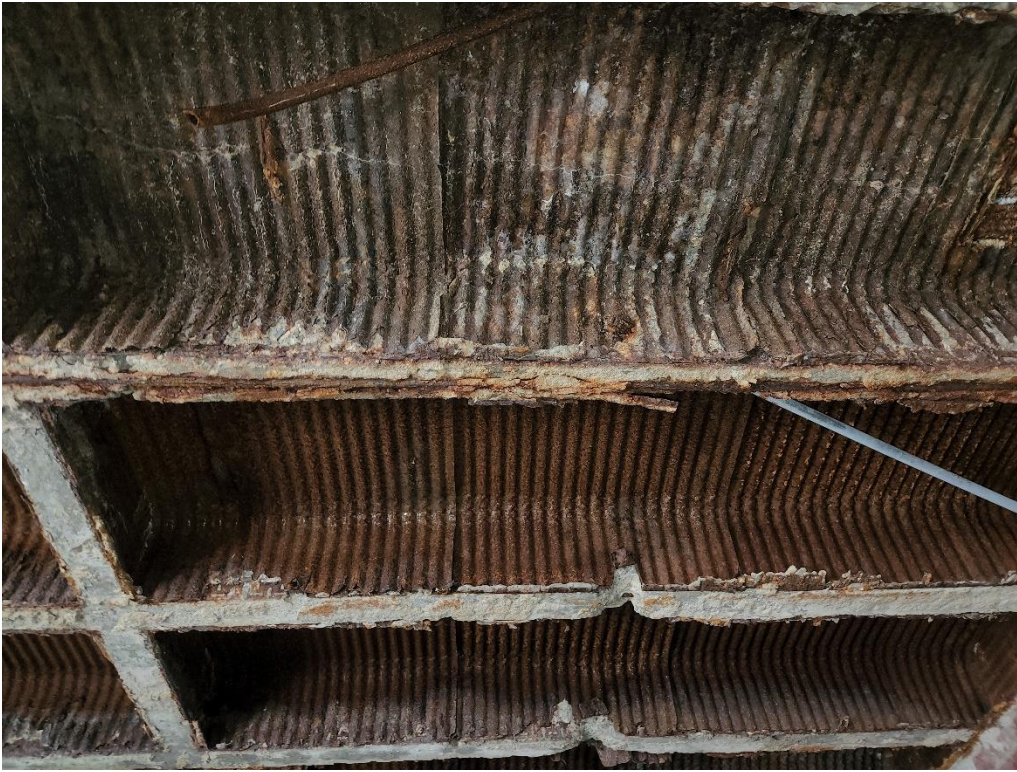
- There are several concrete ribbed beams where the bottom of the rib has cracked concrete, exposing the steel reinforcement (See Picture 1). This exposed reinforcement is severely deteriorated and is, in some locations, no longer bonded to the concrete. The concrete debris shall be removed and new steel reinforcement shall be added on the bottom of the rib to become the new structural support. There were (23) instances where this was observed, although there are likely more that could not be observed due to debris.

Picture 1: Concrete at the ribbed beams have cracked and exposed the reinforcement, allowing significant deterioration to occur.

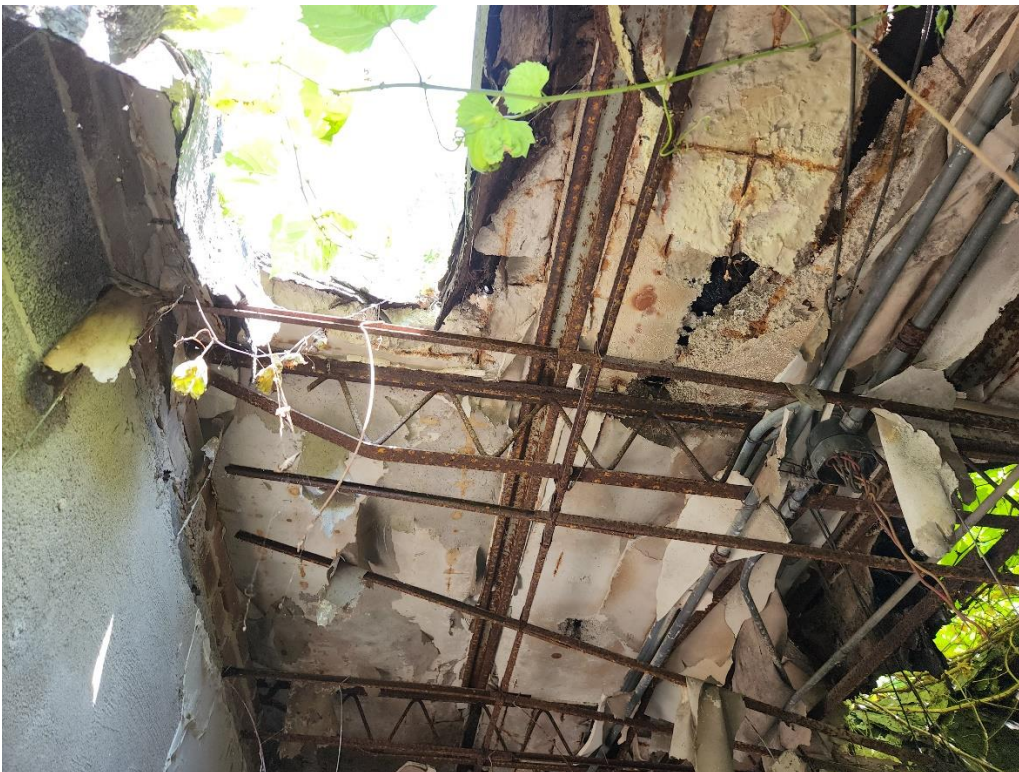
- All structural steel, with the exception of the 3<sup>rd</sup> story addition on top of the original structure, is severely deteriorated with significant portions of the steel being delaminated (See Pictures 2-5). This steel shall be completely demolished. The areas affected include West Annex roof, Walkways, stair structures, and exterior brick opening lintels.

Picture 2: The West Annex roof has collapsed, exposing the structural steel to the elements, and has caused significant deterioration.

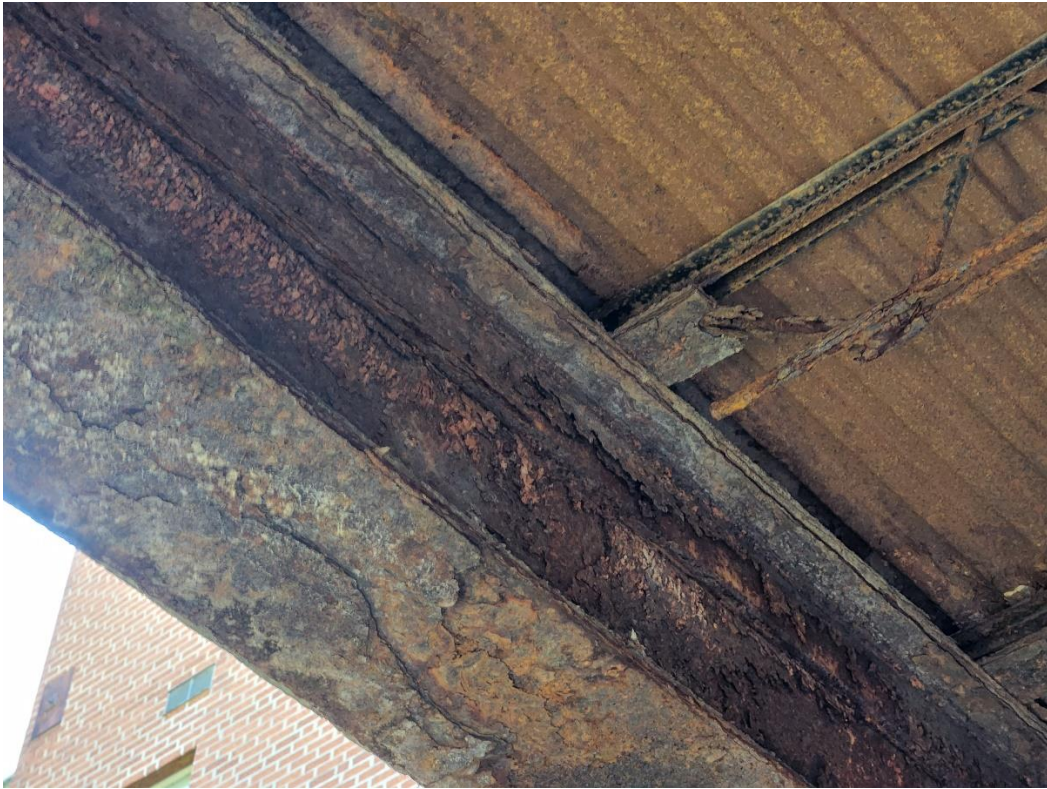
Picture 3: Steel at the exterior walkway is severely deteriorated to the point that it has delaminated.

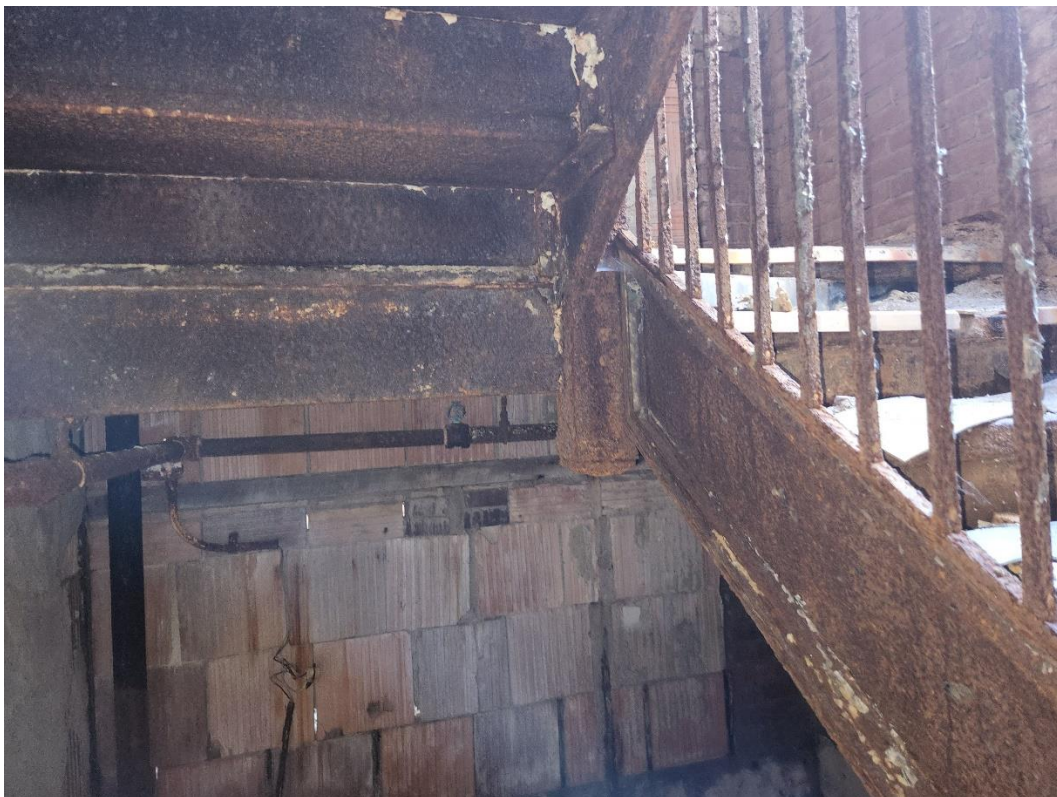
Picture 4: The steel stair structure is severely deteriorated and shall be replaced.

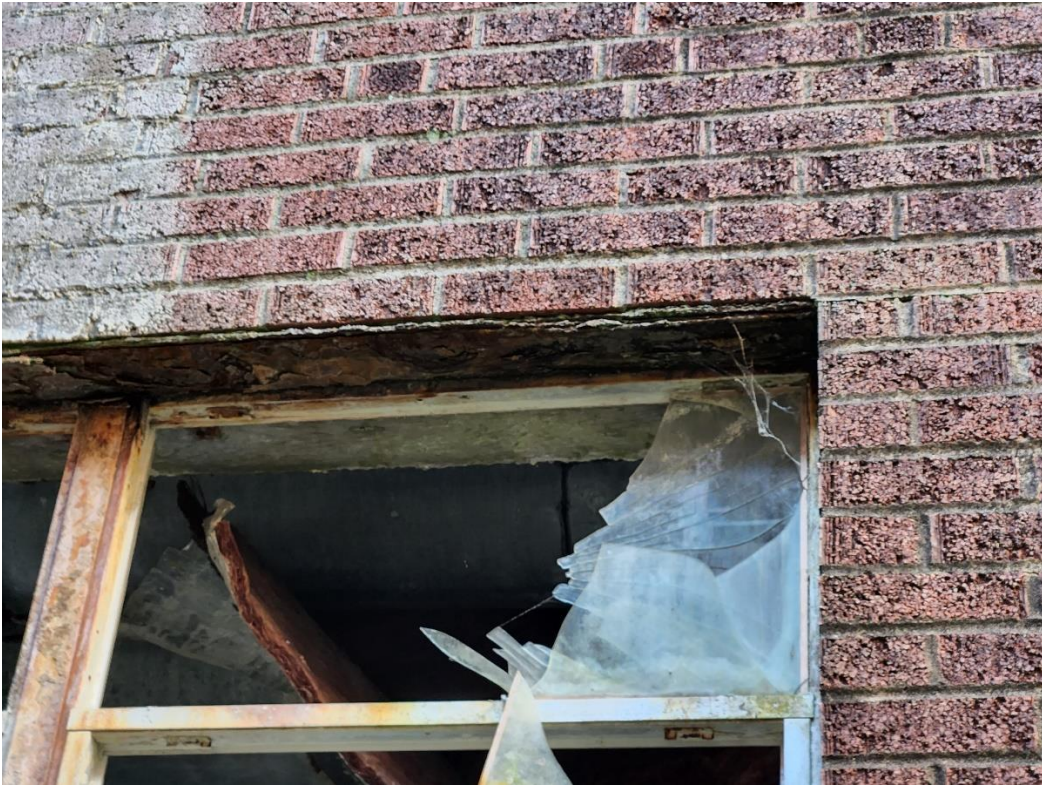
Picture 5: Exterior steel lintels are severely deteriorated and shall be replaced.

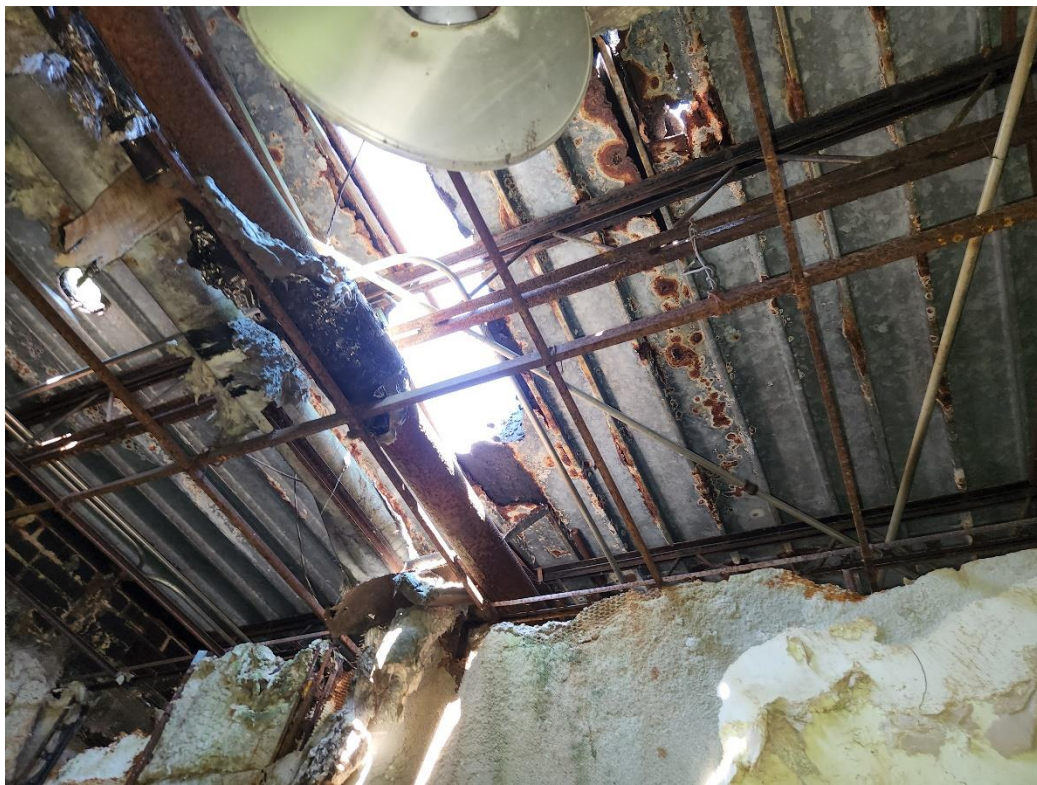
- The structural steel on the 3<sup>rd</sup> story roof addition has slight deterioration. The deterioration shall be cleaned, and the steel shall be painted with a rust-inhibiting paint. The steel roof deck in this area is severely deteriorated and shall be replaced. (See Picture 6)

Picture 6: The steel bar joists on the 3<sup>rd</sup> floor addition's roof are slightly deteriorated and the roof deck is severely deteriorated.

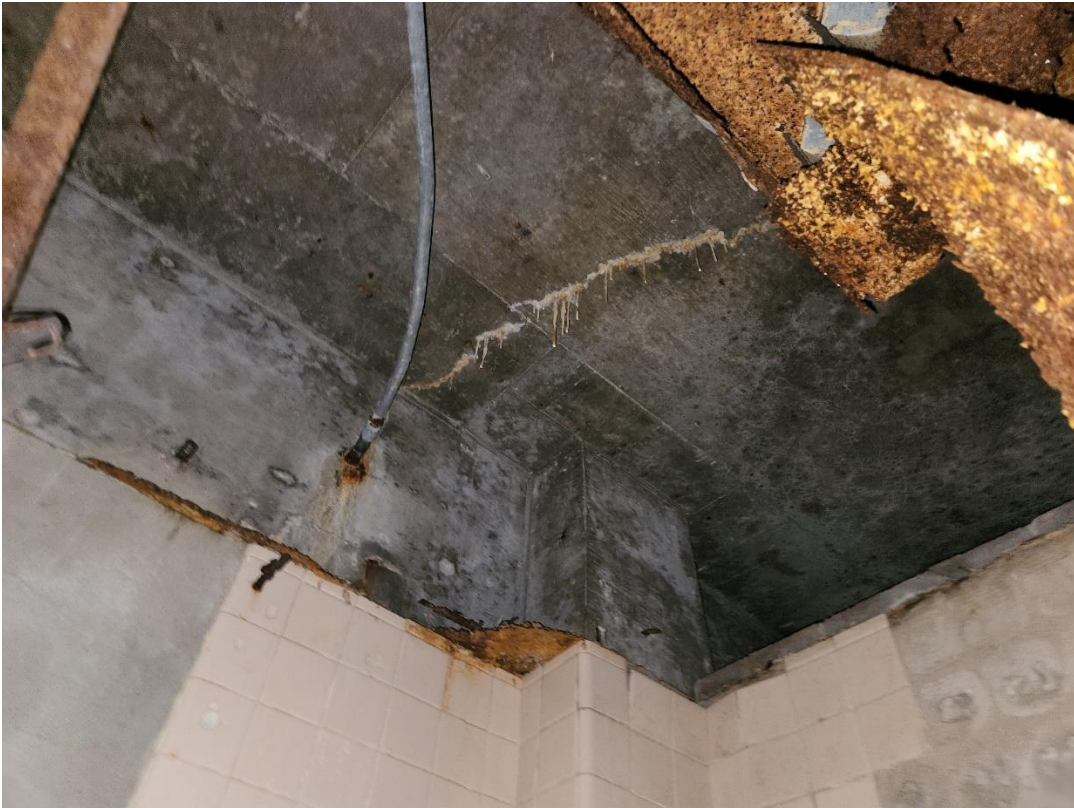
- There are several cracks in the concrete slabs at the South Annex (See Picture 7), which do not appear to have caused significant structural damage. These cracks shall be sealed with an epoxy sealant to prevent deterioration.
- The exterior concrete masonry walls of the penthouse have cracked in several locations (See Picture 8). These cracks shall be tuck pointed to prevent water infiltration.
- There are several cracks in the exterior brick veneer (See Picture 9) and there are instances where the mortar in the stone foundation of the original structure is crumbling (See Picture 10). These locations shall be tuck pointed to prevent water infiltration.

Picture 7: Crack in the concrete slab at the South Annex has allowed calcification to form.

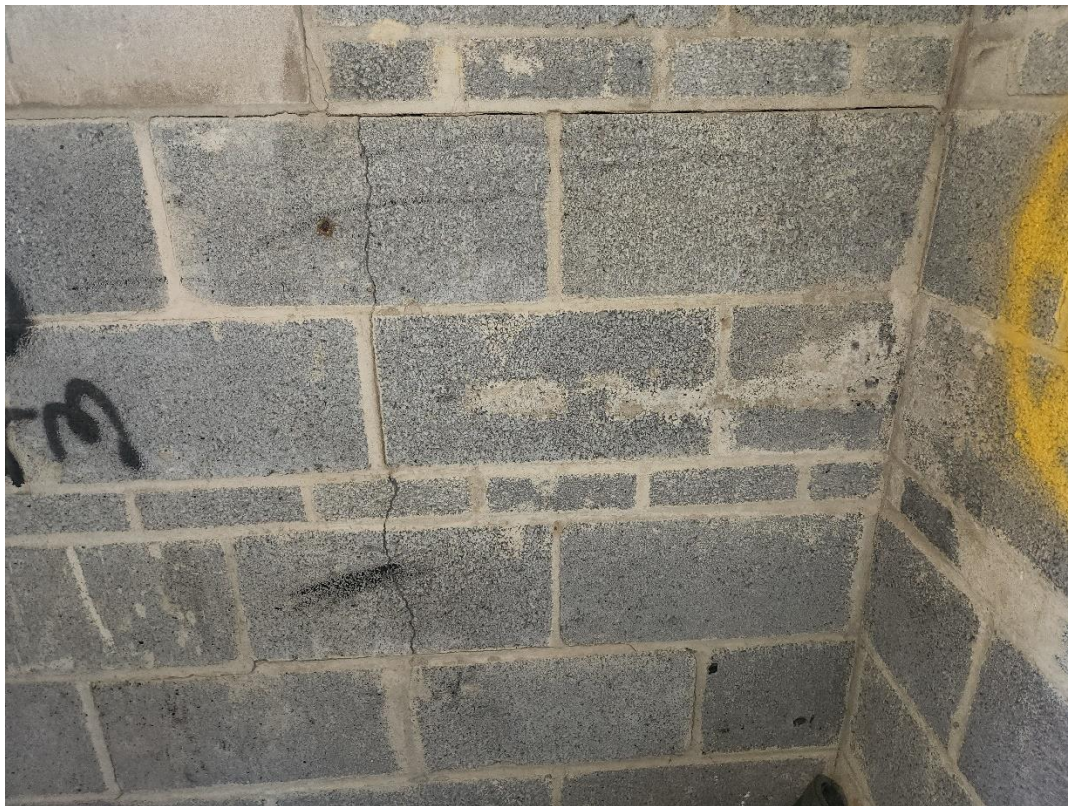
Picture 8: Cracks in the exterior concrete masonry walls at the penthouse shall be tuck pointed.

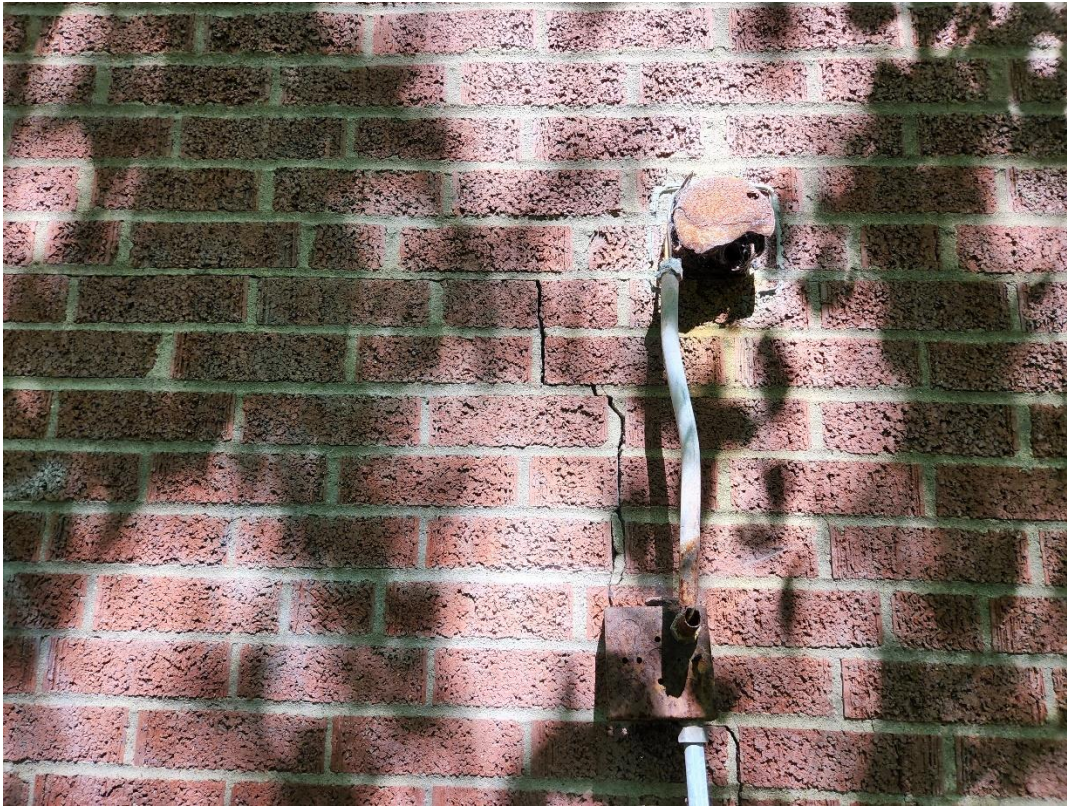
Picture 9: Cracks in the exterior brick veneer shall be tuck pointed.

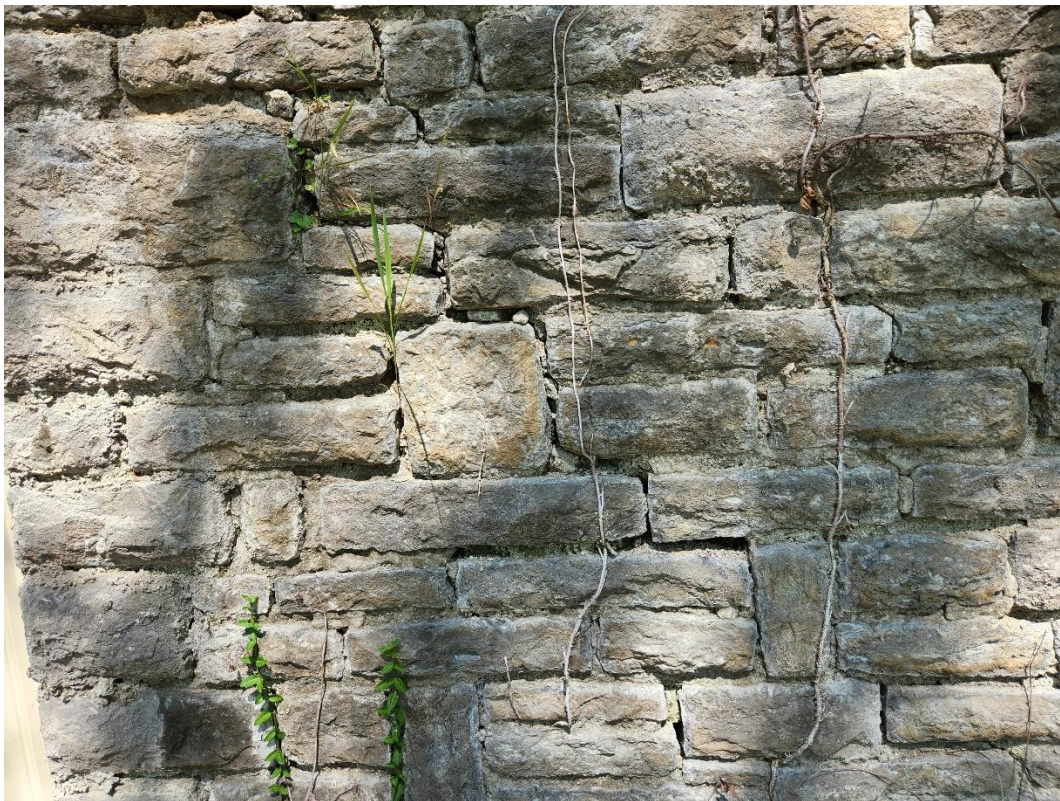
Picture 10: Deteriorated mortar in the stone foundation walls shall be tuck pointed.
