Former Hayswood Hospital USEPA Cleanup Grant

RFP Bid Walk Questions/Reponses & Additional Clarifications to Bidders Regarding Roofs and Windows

Date Issued: October 11, 2024

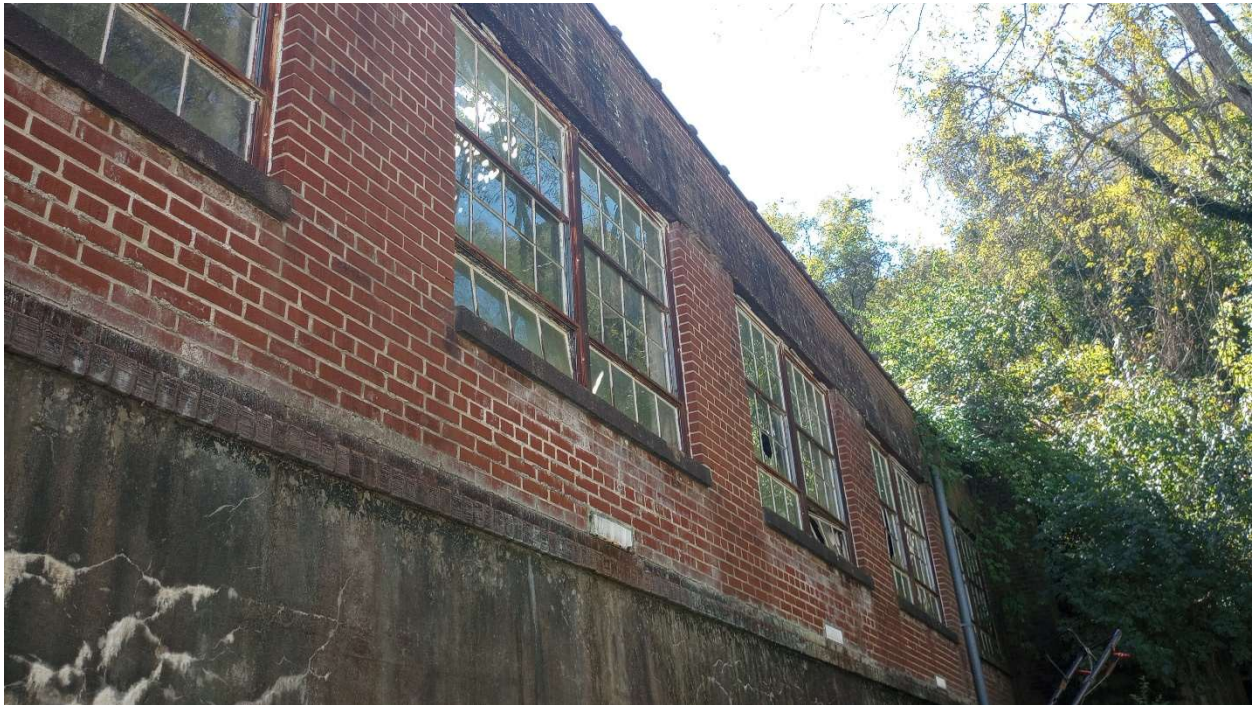
All windows are considered to have asbestos mastic, and some also have asbestos glazing. Due to the possibility of SHPO Historic Renovation Credits, some asbestos containing windows may be retained. The number to be retained will be determined later.

1. All windows and frames removed and replaced with 7/16" plywood. This is a lump sum price for every window in the building.
2. Removal of asbestos mastic and glazing and glass from a single window frame. Assume the window is as shown below. The window consists of 20 panes of glass with asbestos glazing and mastic. Glass may be removed and disposed. 7/16" plywood will be installed for weather protection.
